Innovative Leak Detection

Vehicle: 1994 Chevrolet Suburban with 85,000 miles
Problem: Coolant leak

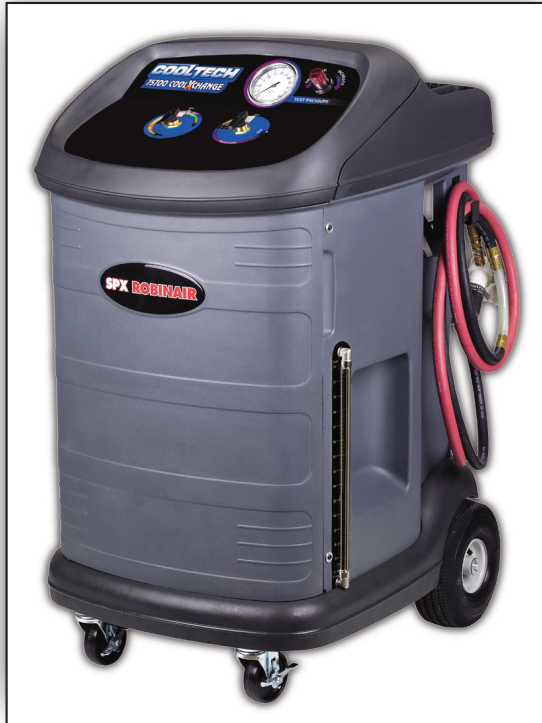
Recently, I was doing a dye check inspection with a black light on a Chevy Suburban to find the source of a coolant leak. The source of the leak was in the back of the engine, and the repair would require removal of the transmission. After presenting the estimate and getting customer approval, we started by removing the transfer case and transmission. It was obvious that the cause of the coolant loss were the two freeze-out or core plugs in the back of the engine. They were both rotted clean through in the corners and their failure was not in doubt.

After replacing the plugs, however, I was a little cautious about putting the vehicle back together because I wondered if the new core plugs did, in fact, “seat square” and more importantly would not leak. I started to go for the pressure tester to see what a load of 15 psi would do, but then I spotted my new Robinair Model 75700 Coolant Exchange machine. Why not hook that up and flush the coolant with the transmission out? The 75700 is designed to work with the engine off and this was clearly the best way to go. Not only would it pressurize the system, but it would also push coolant through, creating some turbulence, thereby duplicating actual coolant system operation.

I quickly hooked up the correct adapters for the upper radiator hose, filled the machine with coolant and within a matter of 15 minutes verified that the repair was in fact, “good-to-go.” This gave
