OTC Repair Strategies:

Diagnosing Emissions Failure Quickly and Accurately

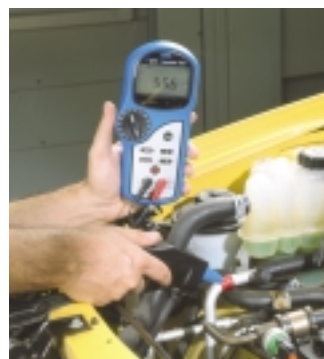
To perform the short cut I back probed the EGR solenoid using the OTC DAT (Digital Automotive Tester) and I installed a vacuum gauge in series between the EGR solenoid and the EGR valve. I performed the KOER and monitored the DAT and the vacuum gauge. As the PCM commanded the EGR to open I noticed the DAT showed varying voltage indicating the solenoid was functioning electrically and that the vacuum gauge read 3 inches of vacuum showing that vacuum was being applied to the EGR valve. While the vacuum was supplied there was no change in engine RPM. With no noticeable change in RPM my diagnosis was that I had almost no EGR flow as a result of either a bad EGR valve or restricted EGR passage.
